Navigator Trolling Motor, 35lb. thrust, 12VDC, Model 3500, Stainless Steel version, ~\$670

MarineTech Products. They are available from many sources, we bought ours from Cabela's.

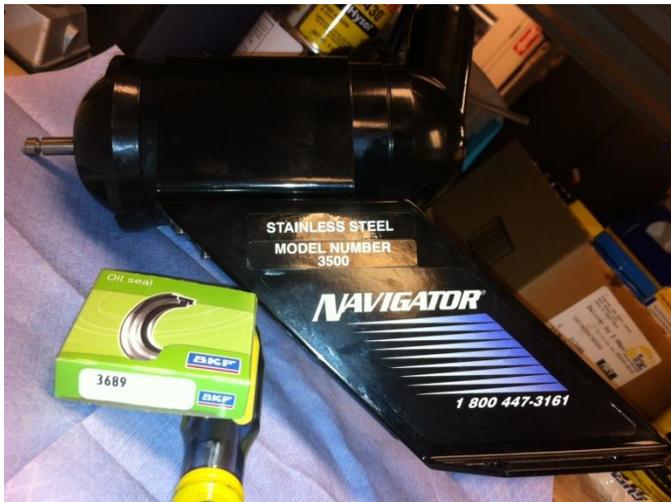
Tools and Parts- SKF seal P/N 3689 or equiv.

- offset screwdriver or tool as pictured,
- silicon grease
- small soft blow hammer
- 1/4" nut driver or socket
- RTV silicon sealant
- self fusing tape, 3M Scotch 70 (typical or equiv.)

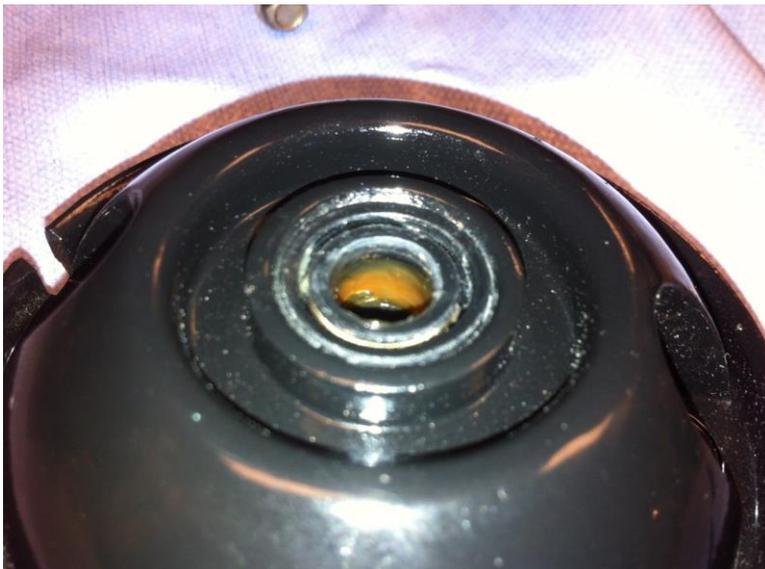
Original seal- NOTE: lip and spring are towards the water (pressure) side.

The water pressure increases the seal effectiveness, new seal must be installed similarly.

-Make sure any spacers (fiber washers) that may have stuck to the inside of the endcap are placed back on the shaft.

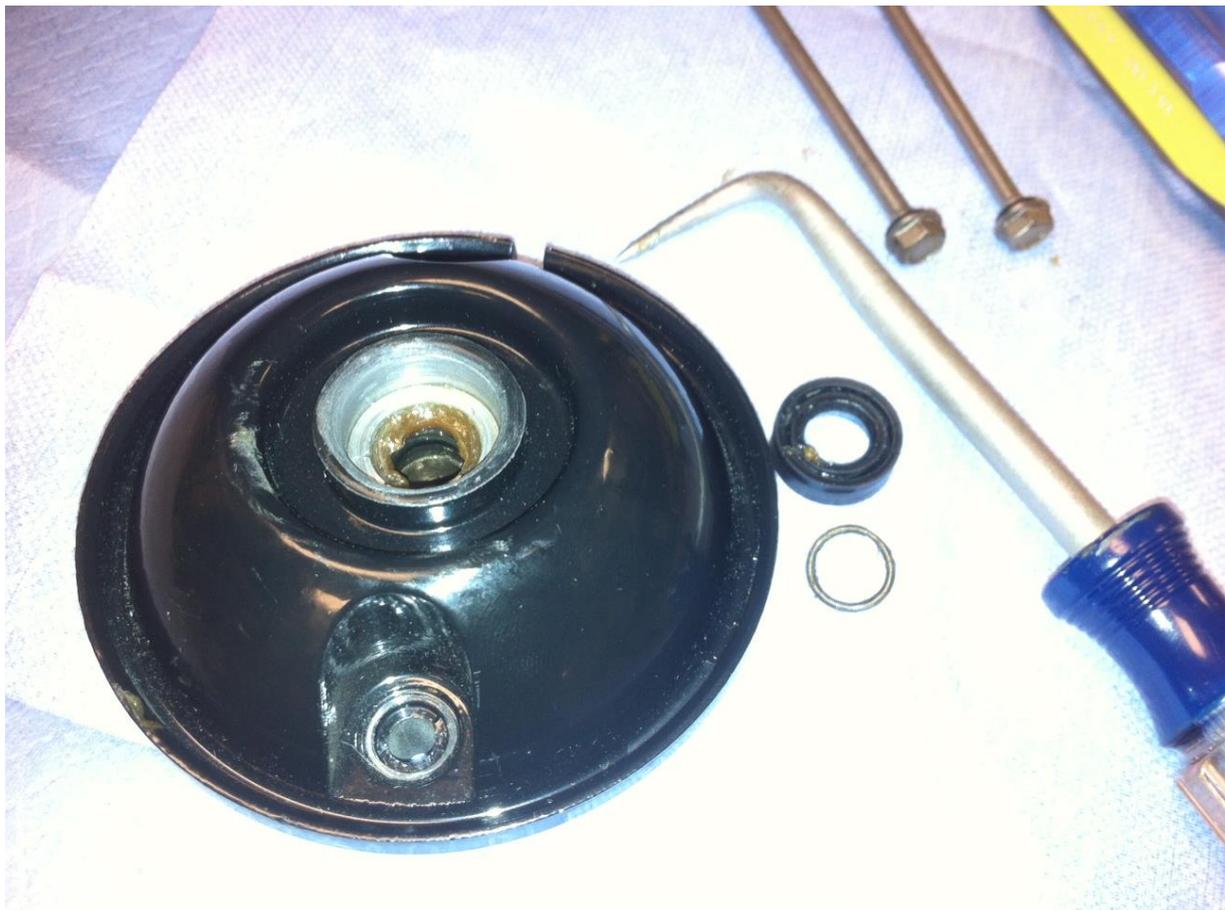
Remove the original seal- The seals are a tight fit when installed so they require some prying to remove. Be careful not to damage the housing seal wall area. The original seal will be destroyed, note the spring popped out. I pried in several directions before it started to move. A small screwdriver works too.

Do not damage the inner (2<sup>nd</sup>) seal.

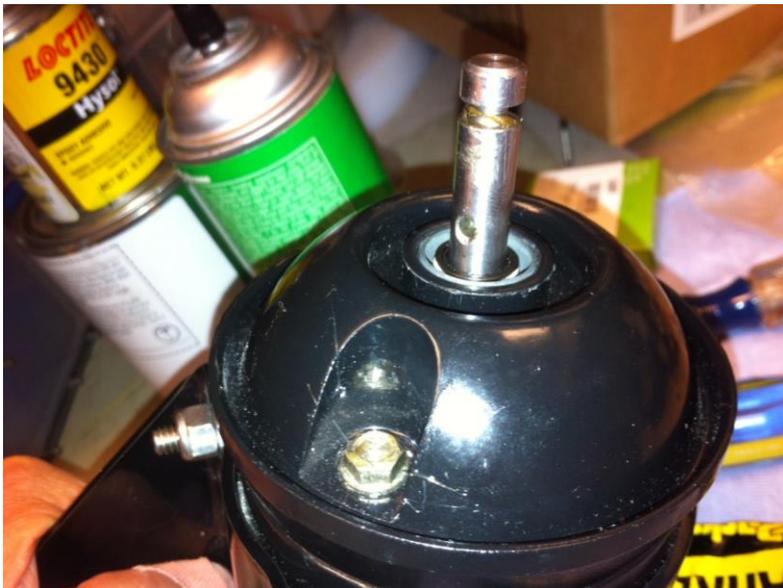
-Fill lip gap where spring is with silicon grease, helps decrease corrosion of the spring. NOTE: Our unit, as modified, was immersed for 2 months with no visible damage to the seal spring and no leaks.

Test -Motor should run normally and identically to performance prior to seal change, Do not run "dry", except for quick check, seal needs lubrication.

Reassemble-

-Lightly lube shaft

-Note the orientation of the gaps in the magnets in the main housing where the bolts gain access to the threads in the rear endcap.

-with a twisting motion slowly slide endcap back onto shaft, line up with the gaps

-Make sure the flat rubber ring seal of the endcap(s) is not twisted, clean and lightly greased

-insert the bolts, a little grease on their threads and oring seals good idea, carefully slide and twist endcap and move bolts till they engage the threads. Twist back and forth and try to center movement so bolts are square to the back endcap. Tighten firmly.

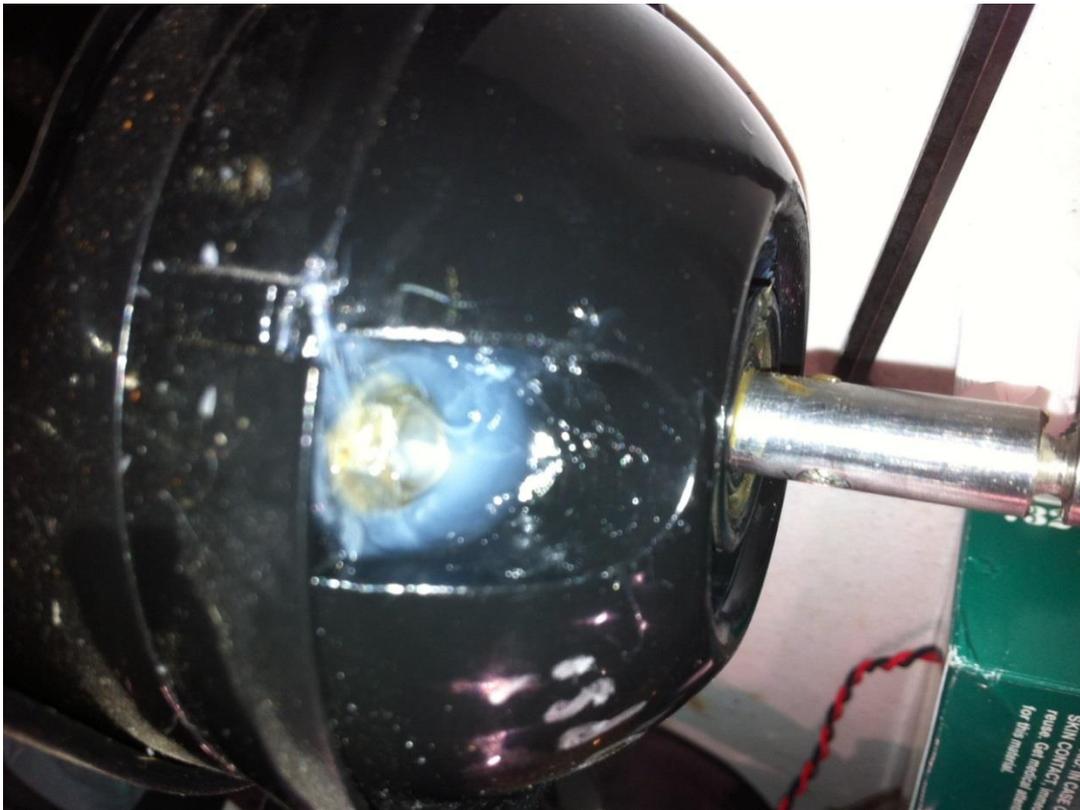
The wire compression seal, the lock set screw and the ass'y bolts are all additional leak points.

-Squeeze a dab of RTV over the ass'y bolt heads.

-Squeeze a dab over the set screw to help seal it as well
